# Capital Reserve Study Update

**KEG File: 17RS-0584**  
**Revised June 30, 2021**

***Del Tierra Homeowners  
Association, Inc.***  
***Progressive Community Management, Inc.***  
***3701 South Osprey Avenue***  
***Sarasota, Florida***  
***34239***

**RE: Del Tierra HOA  
KEG File No. 17RS-0584  
Professional Engineering Services – Capital Reserve Study Update**

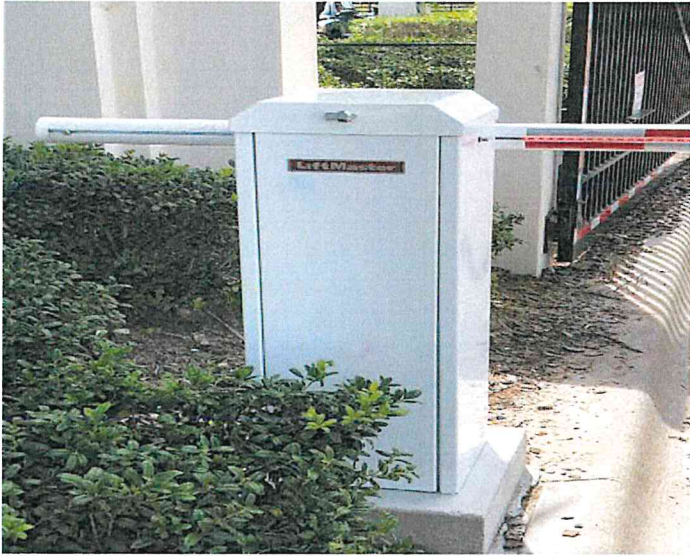
The front entrance has four Viking Gate Operators, and the rear emergency exit has two Nice Operators, for a total of six gate operators. *Additionally, four gate operators have been added to the main entry for a total of eight operators since the original reserve study.*

*Figure 001: Viking Operator added at Main Entrance*

Entry gate operators have an expected useful life of 10 years, and with four years useful life remaining for the operators at the main entrance, we recommend a budget of \$3,500 for each of the four main entry gate motors and operators to be replaced in the year 2025, a total of \$14,000. We further budget \$3,500 for each of the two gate operators at the secondary emergency exit, to be replaced in the year 2025, or a total of \$7,000, but these two operators should have a few additional years extended life due to lack of use currently.

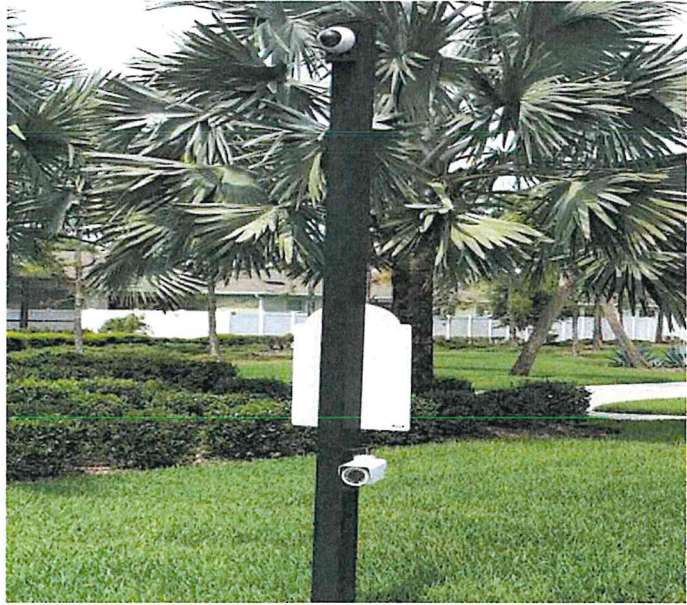
*Figure 002: Typical cameras added at main gate.*

*Also, 13 cameras have been added at Del Tierra, at the pavilion, soccer field, and playground. We budget \$12,350 for 13 cameras with an expected useful life of 10 years and a cost of \$950 each.*

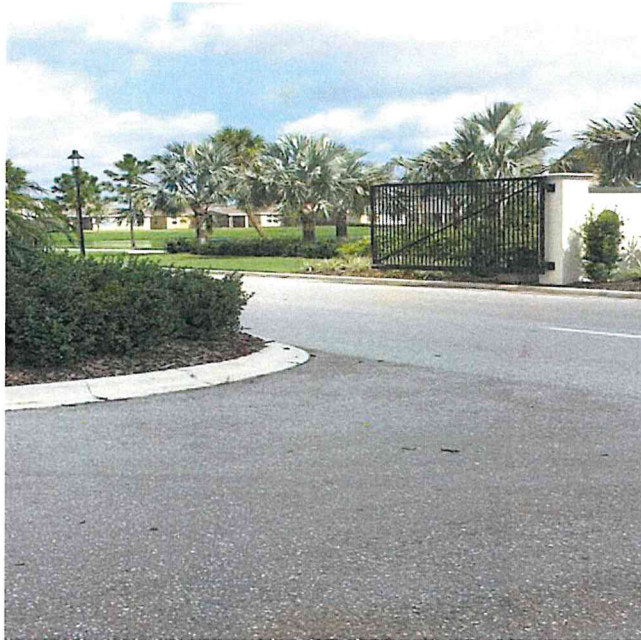
Figure 003: Entry gates at main entrance.

The main entry has four gates 16' wide plus two pedestrian gates of 4' height, and the emergency rear exit has two gates 14' wide. With an expected useful life of 30 years, we budget \$9,000 for replacement of all six gates in the year 2045.

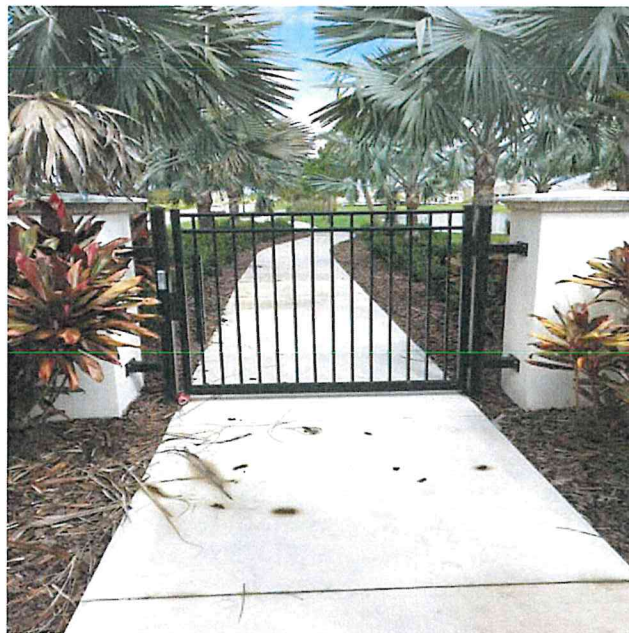
Figure 004: Pedestrian gates at main entry.

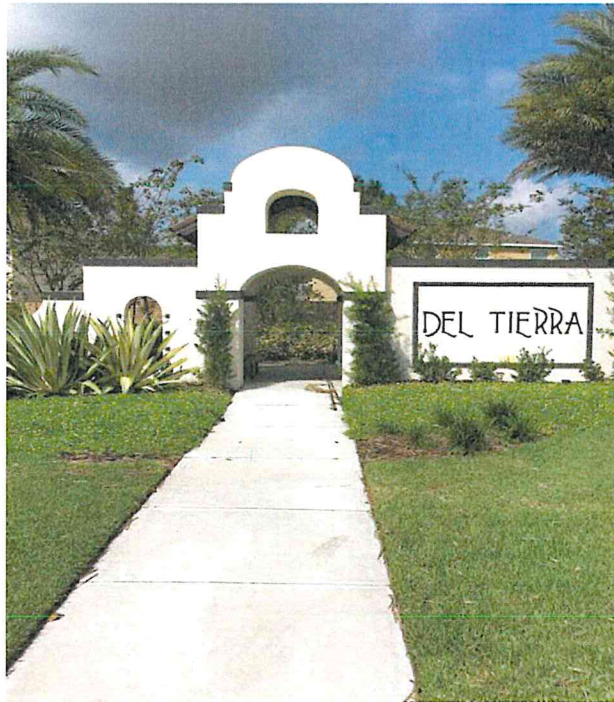
The monument at the front entry bus stop appears to be a masonry structure with stucco cladding and is in excellent condition. The structure itself, should not require replacement and should have an expected useful life exceeding 40 years. With an expected useful life of seven years for the paint finish, we recommend the

Figure 005: Monument at Bus Stop

monument be repainted every seven years, with exterior stucco checked for cracking and deterioration, and appropriate remediation completed. We also recommend the monument be pressure washed every 3-4 years to remove contaminants and assist in preserving the exterior finish useful life. Refer to Figures 005, 006, and 007. *We budget \$3,000 for pressure washing, repainting, plus any additional stucco remediation that may be necessary, for the bus stop monument beginning in the year 2023, to be repeated every seven years.*

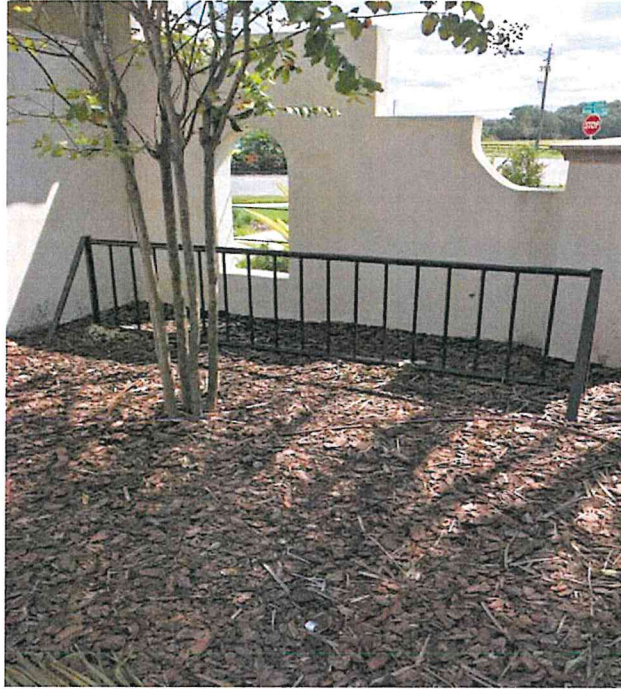
Figure 006: Bike racks at Bus Stop Monument

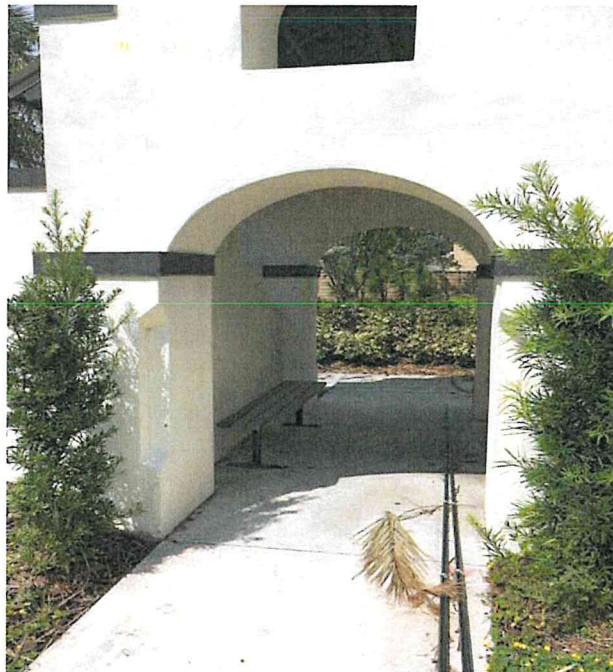
Figure 007: Front of Monument at Bus Stop

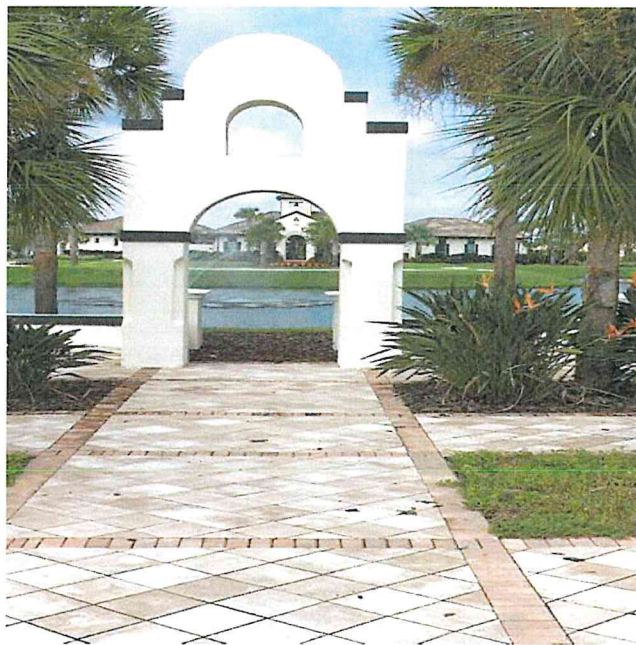
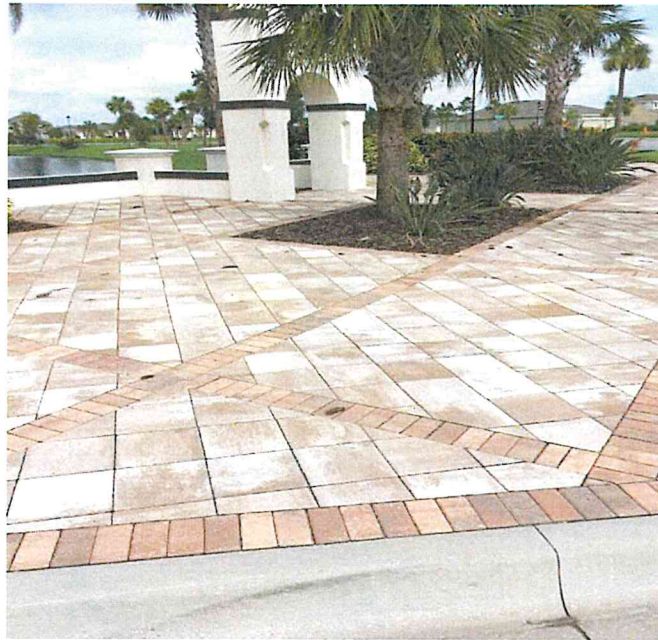
The paver area surrounding the coffee park is in excellent condition and consists of approximately 1,950 square feet of pavers. See Figures 008 and 009.

Figure 008: Coffee Park and Pavers

*With a useful life of 30 years for the pavers, and 24 years remaining, we recommend the pavers receive pressure washing and sealing every three years at a cost of \$750, beginning in 2018, and further budget replacement of the pavers in the year 2046, at a cost of \$9,750, or a unit cost of \$5.00 per square foot.*

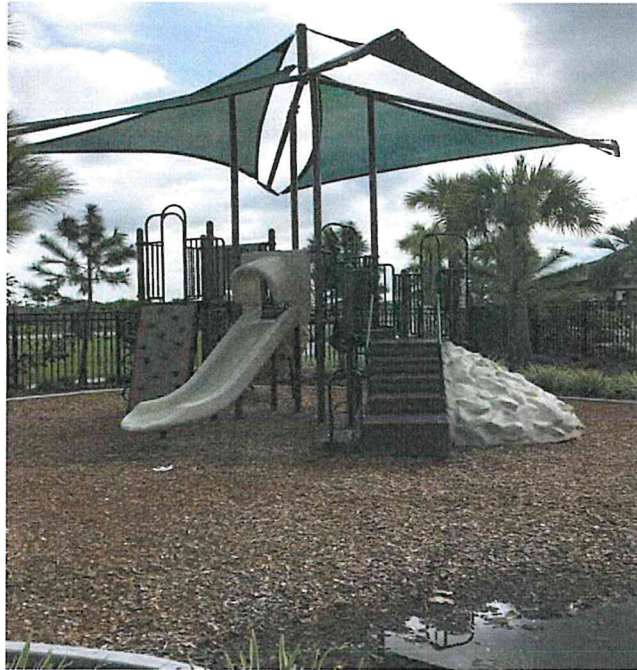
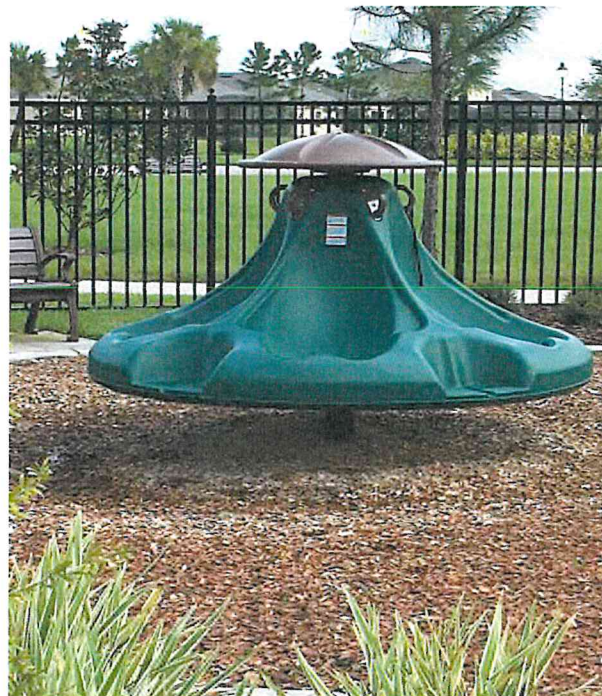
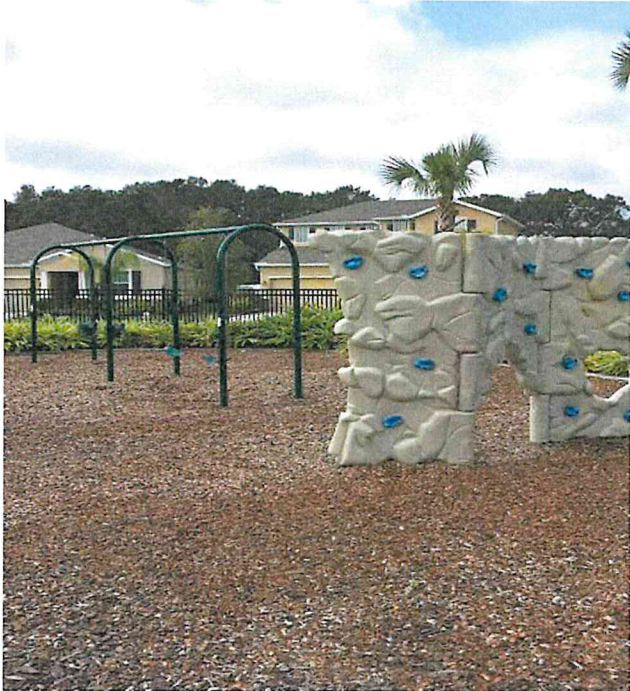
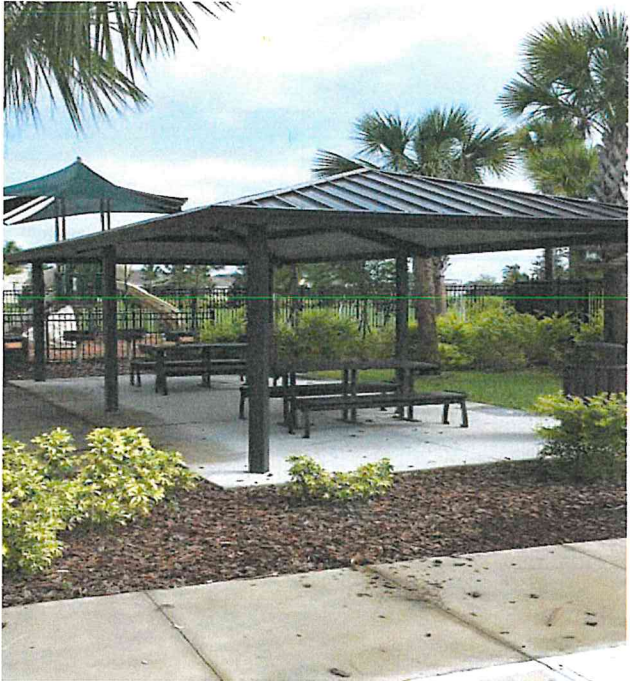
Playground area adjacent to the pool area consists of typical play structures, all in excellent condition. Picnic tables and trash receptacles were placed for optimum use, and are also in excellent condition. Playground fencing is prefinished aluminum and is also in excellent condition. There is also bronze standing seam metal roofing covering the picnic tables. See Figures 010, 011, 012, and 013.

*With an estimated useful life for playground equipment of 12 years, and 7 years remaining, we budget \$32,000, for replacement of all playground equipment, picnic tables, and waste receptacles, in the year 2028, and every 12 years following.*

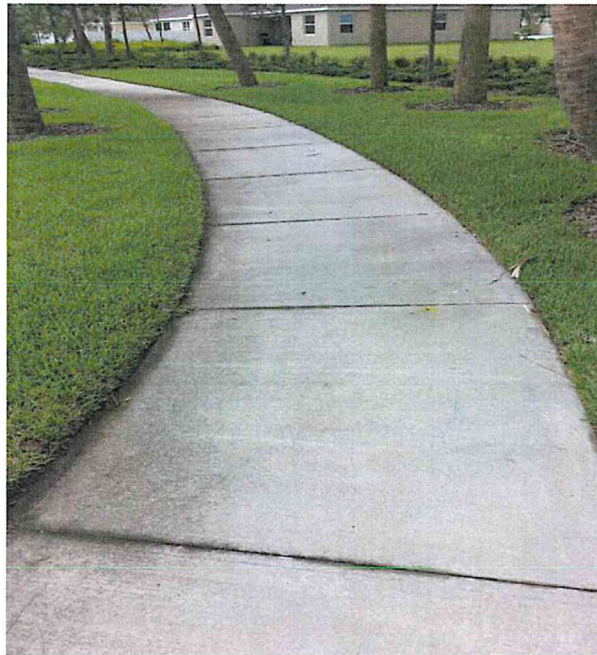
The sidewalks at Del Tierra are in excellent condition and all typical walks are 5'0" wide. With an expected useful life of 50 years, we recommend the association reserve budget includes sidewalk maintenance every five years to remove and replace broken sidewalk areas, or areas that have settled over time. *We therefore budget \$10,000, for sidewalk maintenance and replacement beginning in the year 2026, and continuing every five years. See Figure 014.*

Figure 014: Typical 5 foot wide sidewalk at Del Tierra.

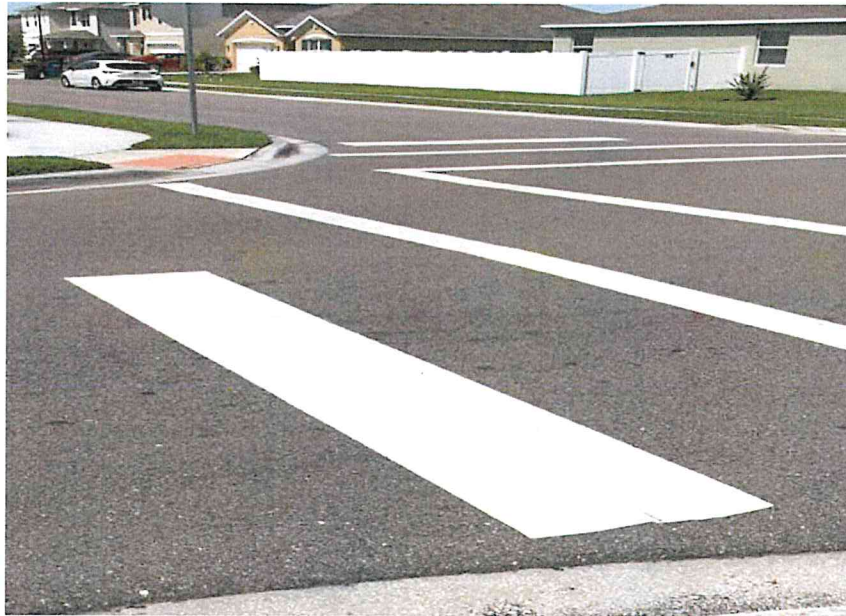
*Del Tierra has a considerable amount of roadways, with approximately 100% of the pavement installed to date. As the pavement is performing better than expected, we forecast a pavement remediation project should not be required until 2038, or approximately 21 years since completed, with a normal expected useful life of 20 years. We budget \$999,600, a unit cost of \$14.00 per square yard with a total of 71,400 square yards pavement, to be done in the year 2038. See Figure 015.*

Figure 015: typical intersection and roadway pavement at Del Tierra.

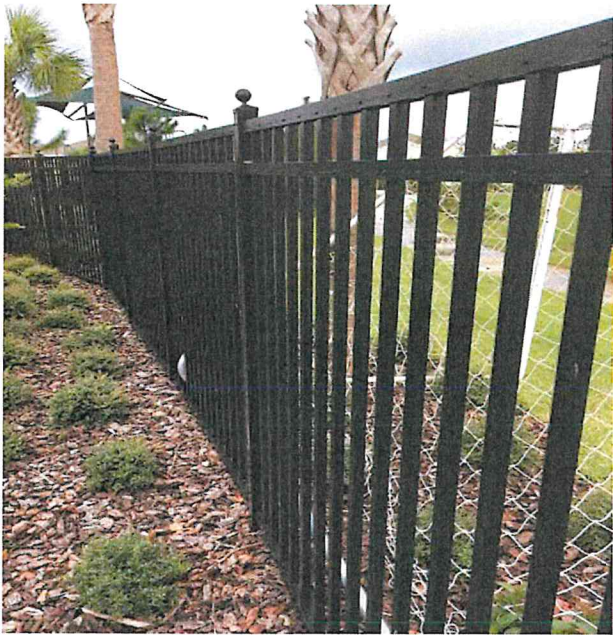
Pool Fence is prefinished aluminum in excellent condition, and with an expected useful life of 15 years, we budget replacement in the year 2031, at a cost of \$32,300, or a unit price of \$38.00 per foot, which includes both the pool fence and the Tot Lot fence, a total of approximately 850 lineal feet. See Figure 016.

Figure 016: Pool fence is aluminum.

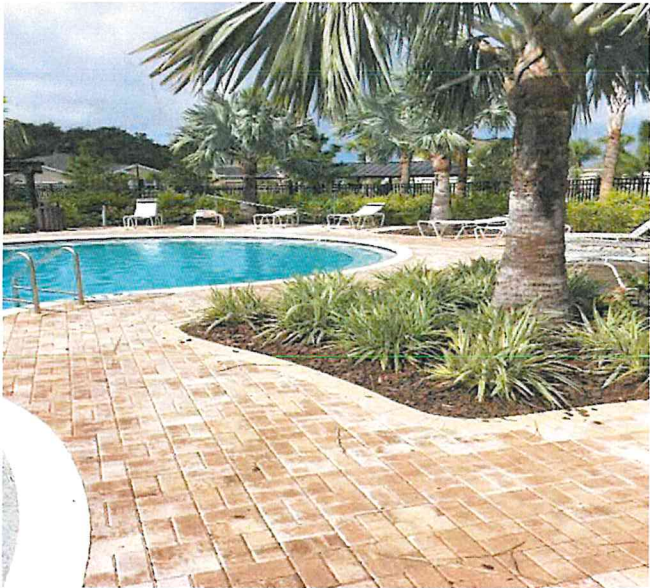
Pool Deck consists of concrete pavers and should be resealed every two years, to prevent contamination of the paver surface. As the paver surface is in excellent condition, we project the pool deck pavers should have a useful life greater than 30 years, exceeding this reserve study. With an area of approximately 5,900 square feet, we budget \$29,500, for pool deck paver replacement in the year 2046, and with an expected minimum useful life of 30 years. We also recommend the pool deck pavers receive pressure washing and sealer every two years, with a budget of \$2,950, beginning in the year 2018. See Figure 017.

Figure 017: Pool and pool deck are in excellent condition.

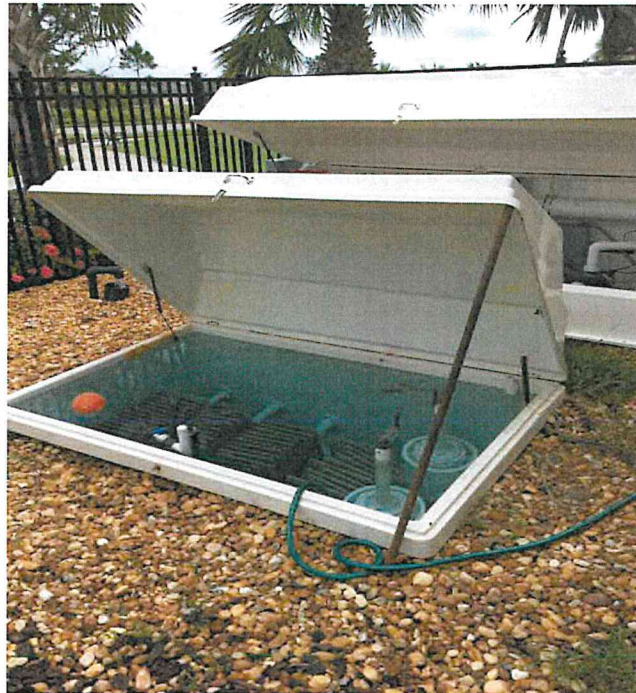
Filters are replaced on an as needed basis with a cost less than \$10,000. Since the filtration system is an Aquaworx package system, we leave filter replacement to be included in the annual pool budget expenses, rather than this reserve study. See Figure 018.

Figure 018: Pool filter system is an “AquaWorx” package unit.

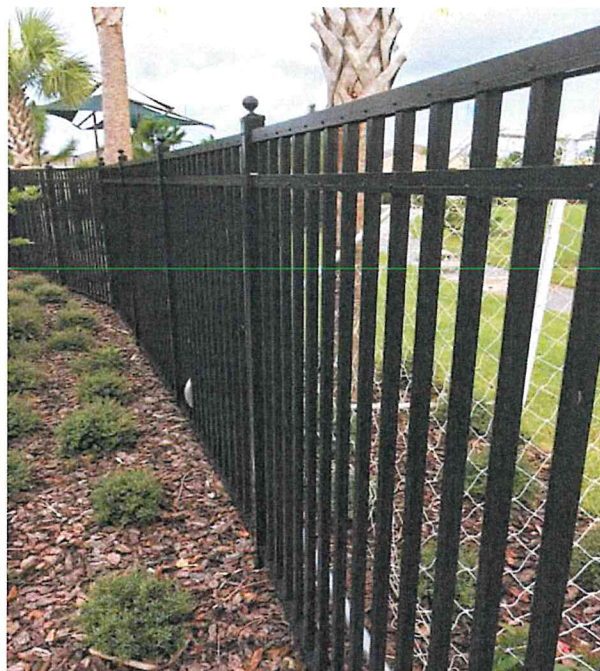
Figure 019: Pool fence and Tot Lot fence are in excellent condition.

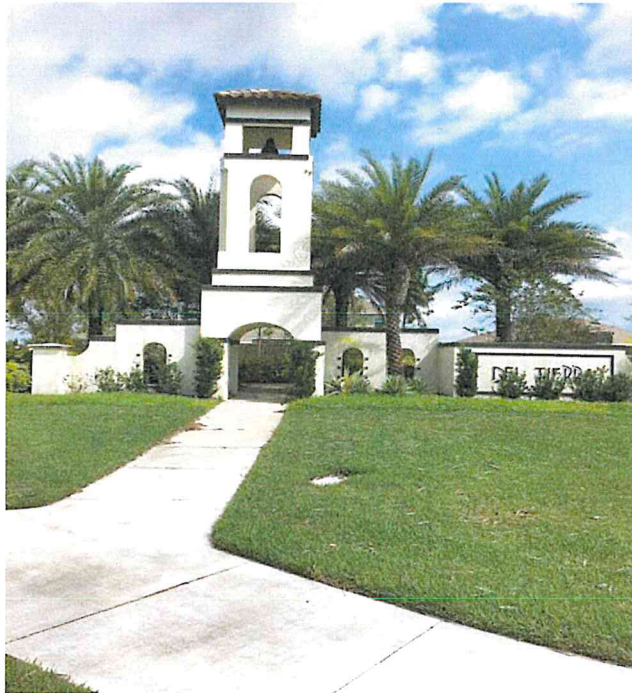
The tower and sign wall are masonry structures with stucco cladding, similar to the monument and bus stop, and are in excellent condition. With an expected useful life exceeding 40 years, the structure should not require replacement during this reserve study with a 30 projection. Refer to Figure 020.

Figure 020: Tower at right side of main entrance.

With an expected useful life of seven years for the exterior paint, we budget \$7,500 for pressure washing, repainting, plus any additional stucco remediation that may be required, beginning in 2022, and continuing every seven years thereafter.

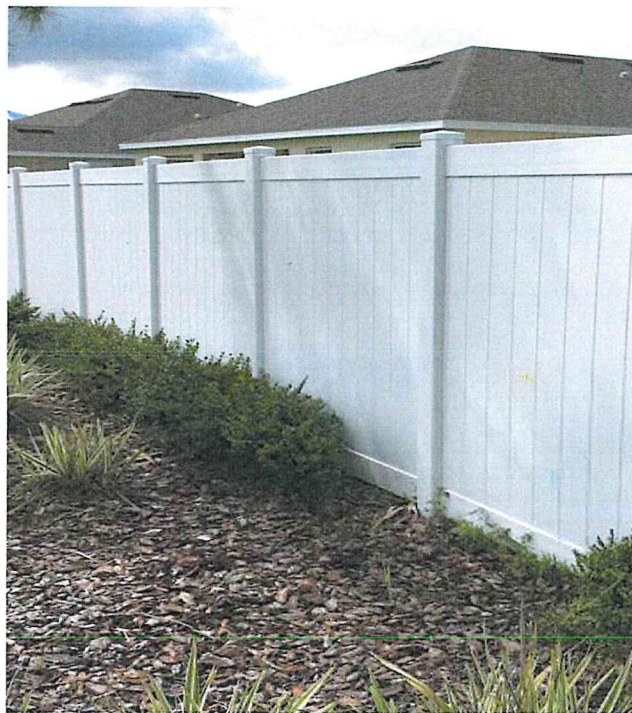
Figure 021: PVC privacy fencing at Del Tierra.

Vinyl/PVC type privacy fencing should have an expected useful life of 30 years, and we budget \$24,000, for replacement of 1,000 LF at a unit cost of \$24.00 per foot. We recommend the vinyl/PVC privacy fence receive pressure washing and cleaning every five years, to be included in the annual budget.

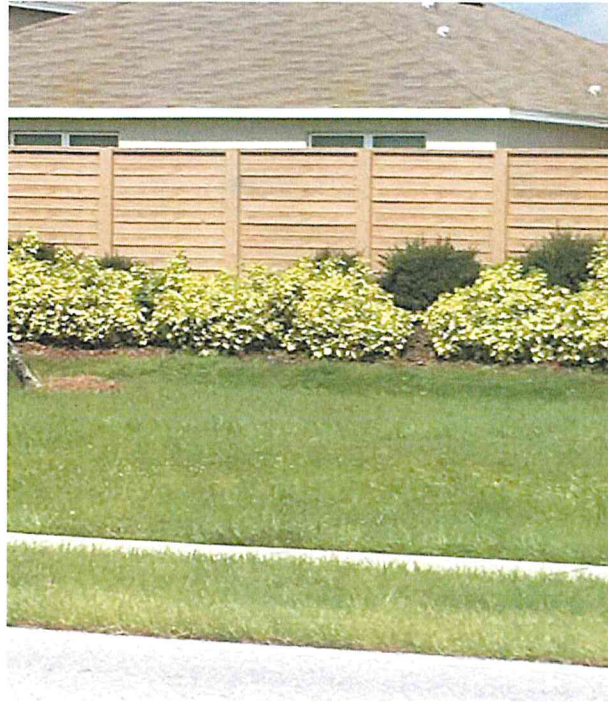
Figure 022: Rough sawn wood privacy fencing at Del Tierra.

The rough sawn appearance composite portion of fencing should have an expected useful life of 40-50 years, exceeding this reserve study. We would budget \$96,000, or \$60/LF for replacement in the year 2065.

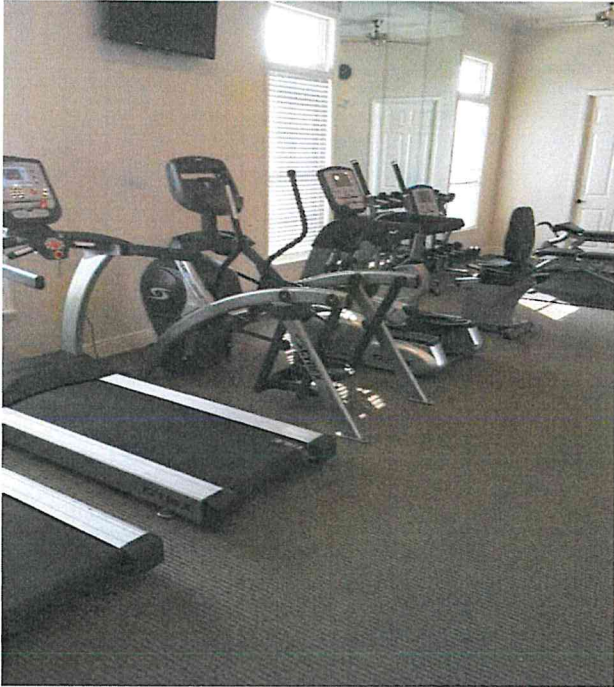
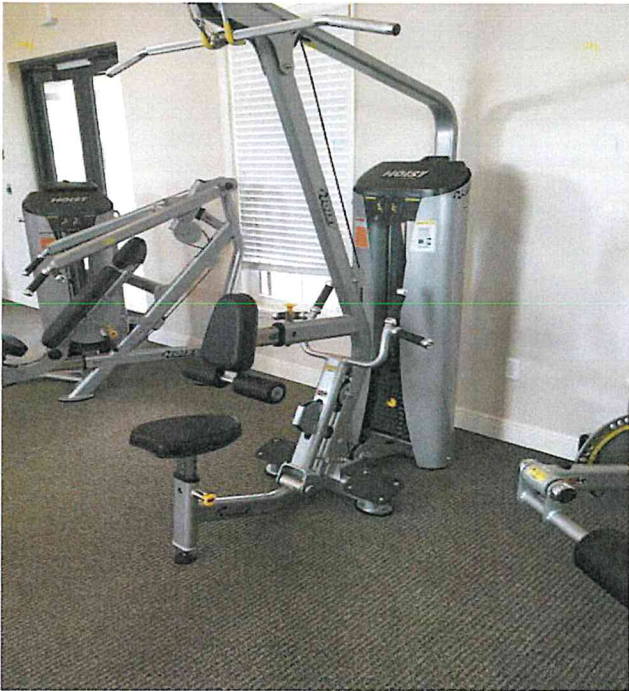
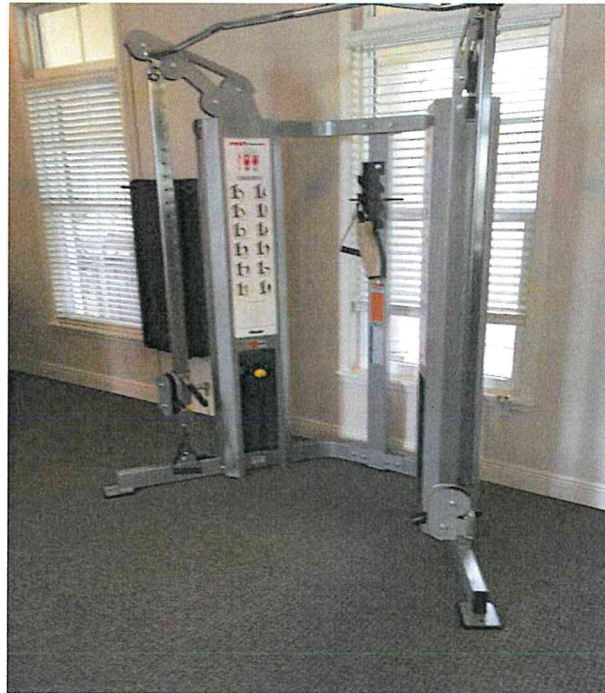
The fitness room at Del Tierra is very well equipped and all machines appeared brand new. The various machines consist of three treadmills, two cross trainers, three universal machines, two benches, and one weight rack.

Figure 024: Exercise equipment appeared brand new.

*We forecast an expected useful life of all exercise equipment as twelve years from the time of total occupancy, to be replaced in the year 2029, and budget \$12,000, for replacement of all exercise machines at that time. Refer to Figures 023, 024, and 025.*

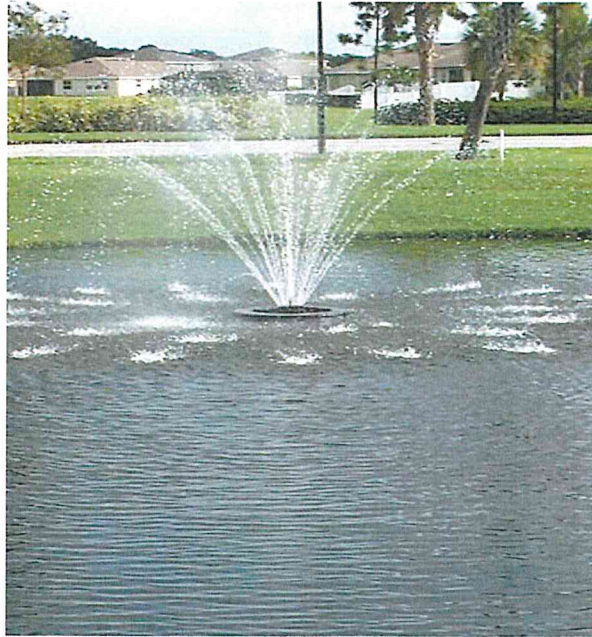
Figure 026: Typical fountain at Del Tierra

*There are ten fountains at Del Tierra, see Figure 026, showing a typical fountain. With an expected useful life of 12 years, we budget \$3,000 per fountain, or a total of \$9,000, for replacement of all ten fountains in the year 2027, and every twelve years subsequent.*

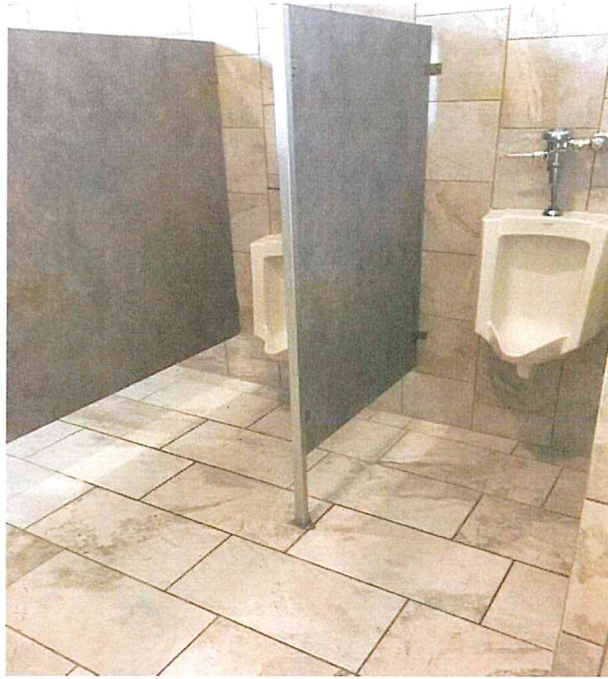
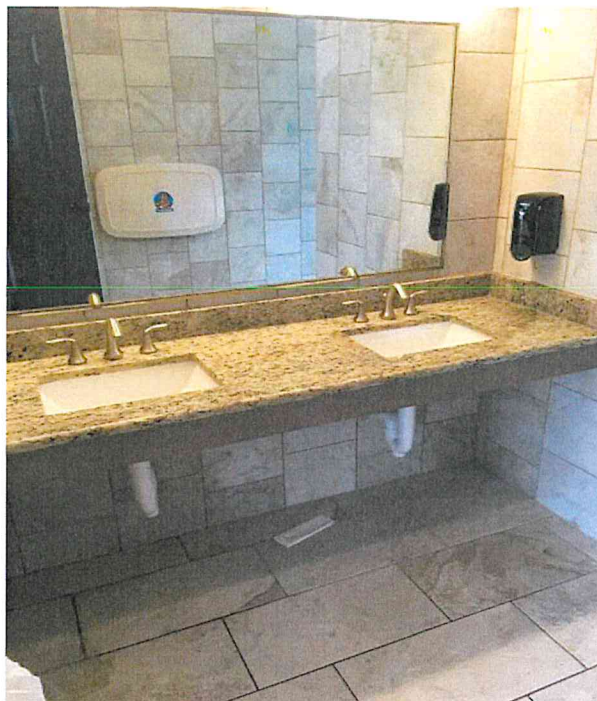
The men's and women's restrooms have a total of eleven plumbing fixtures, all in very good condition. With an expected useful life of 20 years, and with 15 years remaining, we budget \$11,000, for replacement of the eleven plumbing fixtures in the year 2036. See Figures 027 and 028.

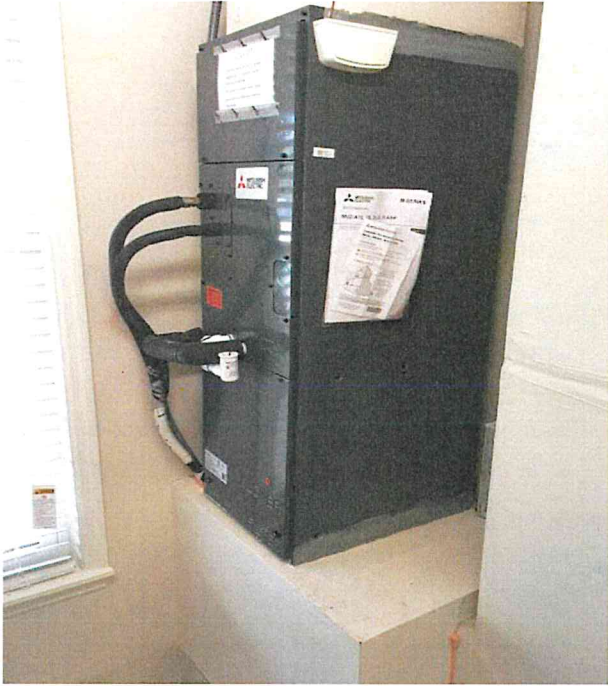
Figure 029: HVAC unit at amenity center.

*There are two HVAC units for office/restroom areas plus one additional HVAC unit for the fitness room and one hot water heater. See Figure 029. With an expected useful life of 15 years, and 10 years remaining, we budget \$9,600, or \$4,800 per unit, for replacement of the two HVAC units in the year 2031.*

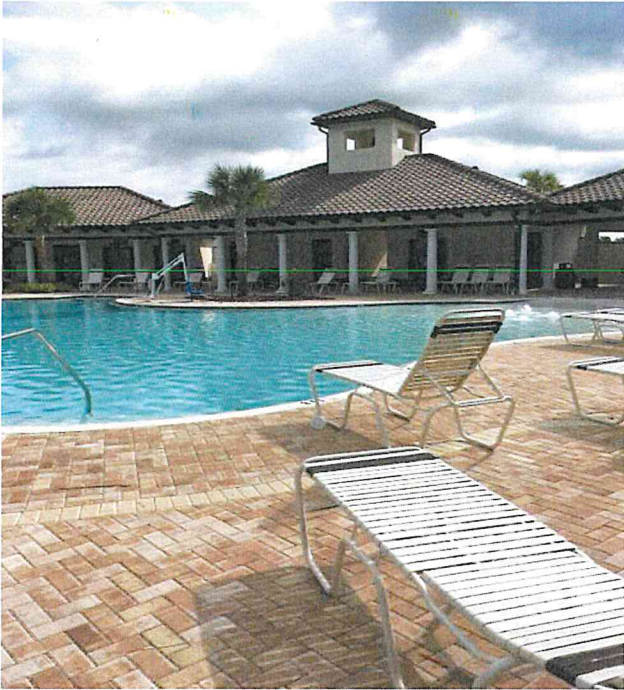
The amenity center/pavilion has a tile roof which has an expected useful life exceeding 25 years, but leaks are normally encountered prior to that time due to failure of the underlayment below the tile roof. Refer to Figure 030. We budget \$41,500, for replacement of 59.5 squares of tile roofing, for the amenity center tile roof in the year 2036, or 20 years following occupancy.

Figure 030: Amenity center has tile roofing.
