# Capital Reserve Study Update

**KEG File: 17RS-0584**  
**Revised June 30, 2021**

***Del Tierra Homeowners  
Association, Inc.***  
***Progressive Community Management, Inc.***  
***3701 South Osprey Avenue***  
***Sarasota, Florida***  
***34239***

**RE: Del Tierra HOA  
KEG File No. 17RS-0584  
Professional Engineering Services – Capital Reserve Study Update**

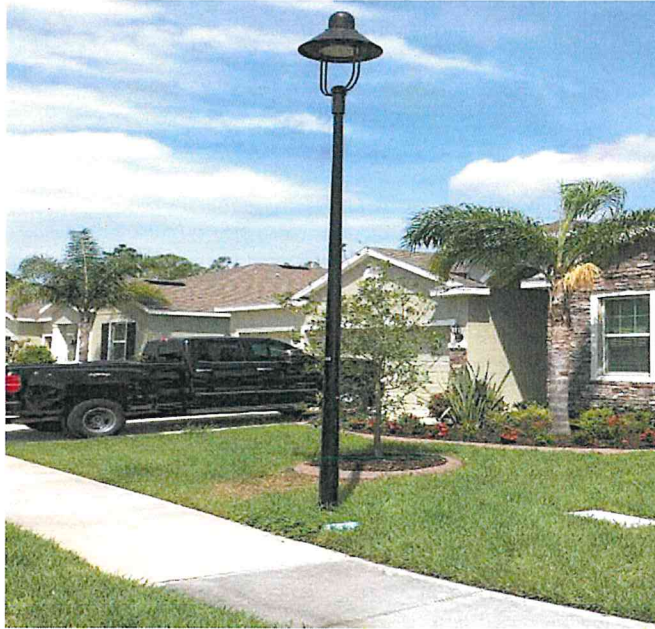
Del Tierra has a total of 164 street light poles. With an expected useful life of 20 years, we budget \$36,900, or \$225 per pole, for replacement in the year 2037.
